CALSPAN ON-SITE AIR BAG/CHILD FATALITY INVESTIGATION

CALSPAN CASE NO. 96-16

VEHICLE : 1996 DODGE CARAVAN

LOCATION: FLORIDA

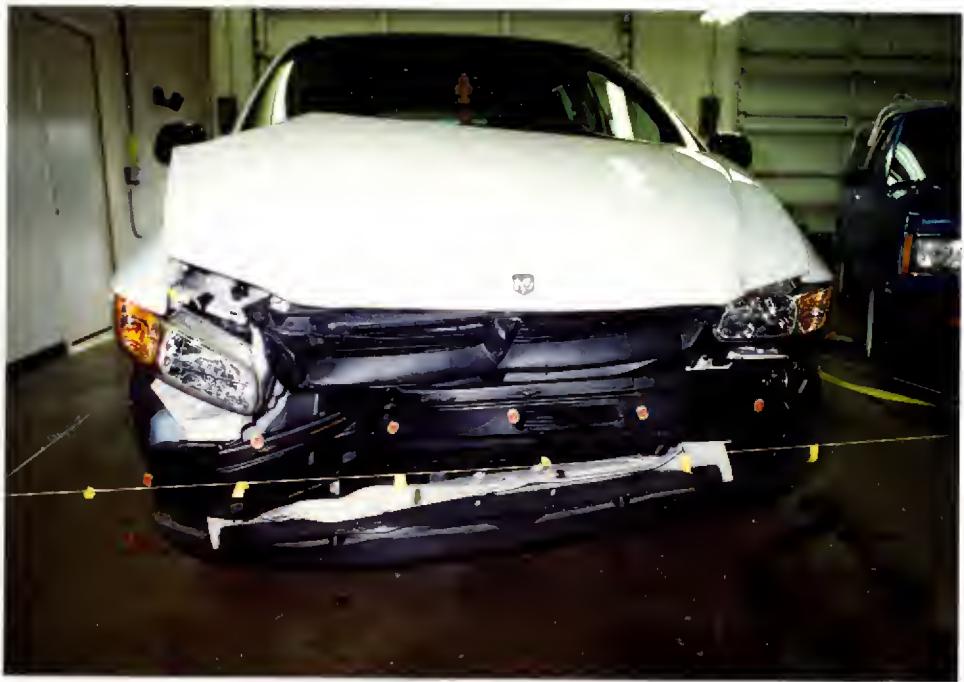
The full frontal area of the Dodge Caravan impacted the right rear quarter panel of the 1966 Chevrolet Impala which resulted in moderate damage to the Caravan. The impact separated the front bumper fascia from the reinforcement bar, therefore the crush profile was documented at the face of the reinforcement bar. Maximum crush was 32.4 cm (12.75") located 12.1 cm (4.75") right of the vehicle's centerline. The crush values at the bumper reinforcement bar were as follows: $C_1 = 4.1$ cm (1.6"), $C_2 = 16.3$ cm (6.4"), $C_3 = 26.9$ cm (10.1"), $C_4 = 32.4$ cm (12.75"), $C_5 = 16.0$ cm (6.3"), $C_6 = 11.7$ cm (4.6").

13. Frontal view of the impact damage to the 1996 Dodge Caravan.

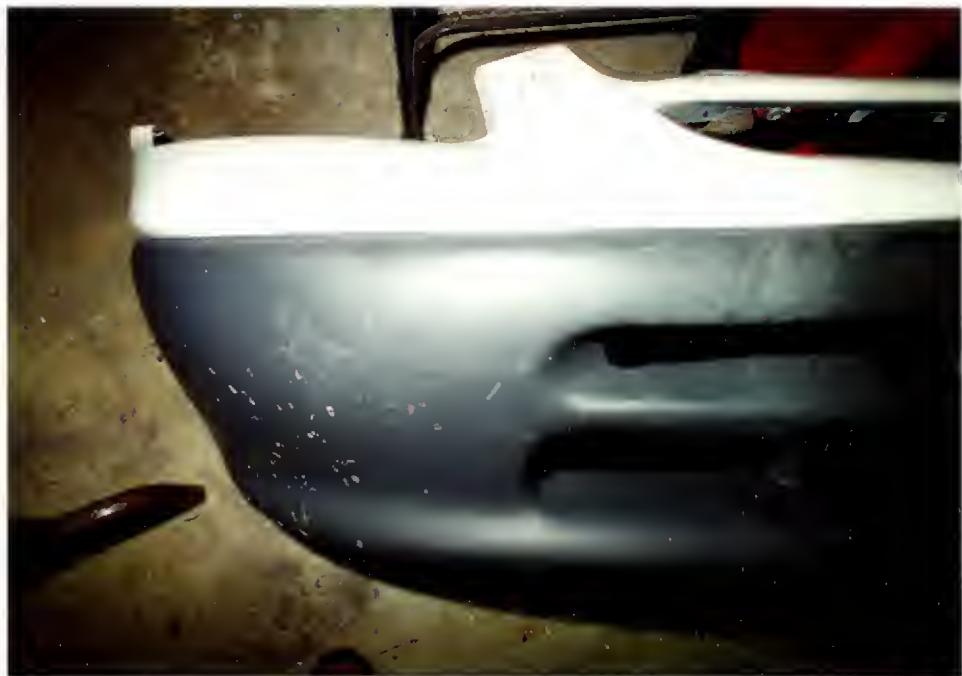
14. View of the front bumper fascia of the Dodge Caravan.

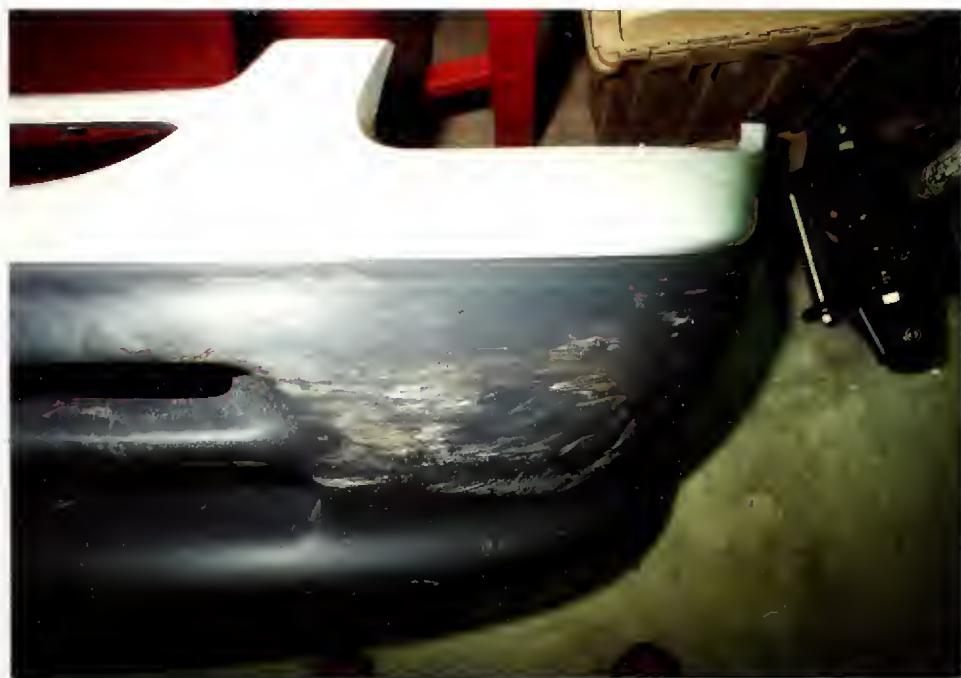
15. Close-up view of the damage to the right corner of the front bumper fascia.

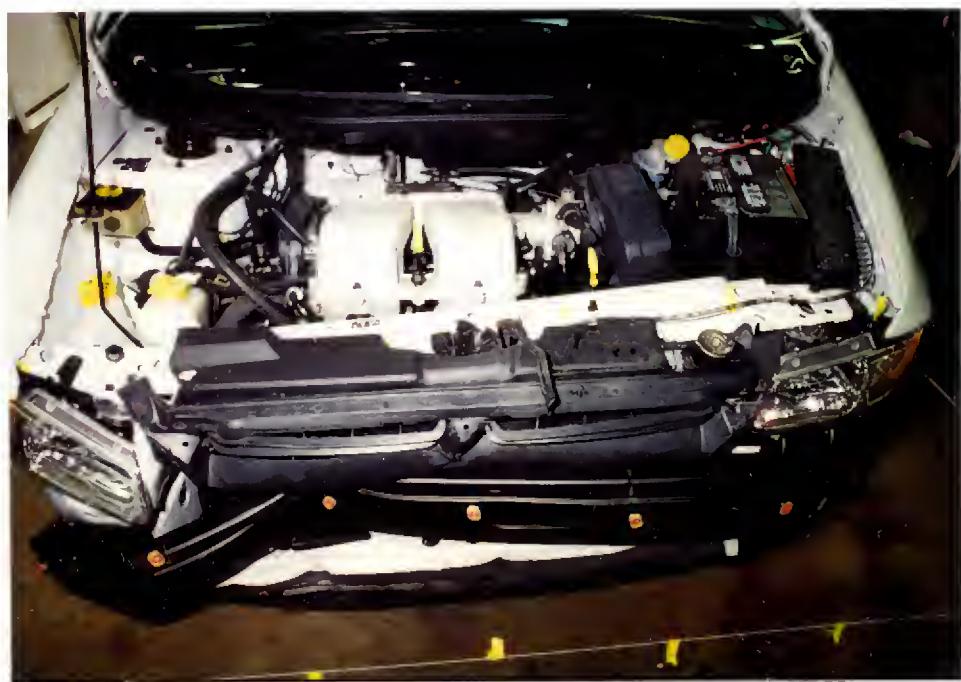
22. Overhead view of the damage to the bumper reinforcement bar and upper radiator support bracket.

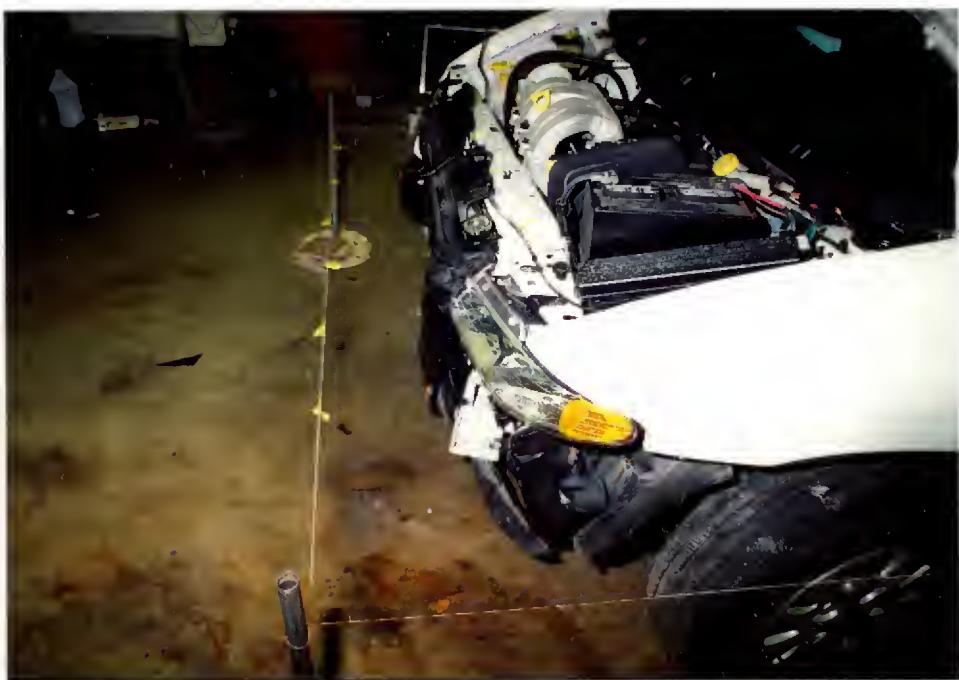
24. Perpendicular view of the rearward displacement of the bumper reinforcement bar and upper radiator support bracket.

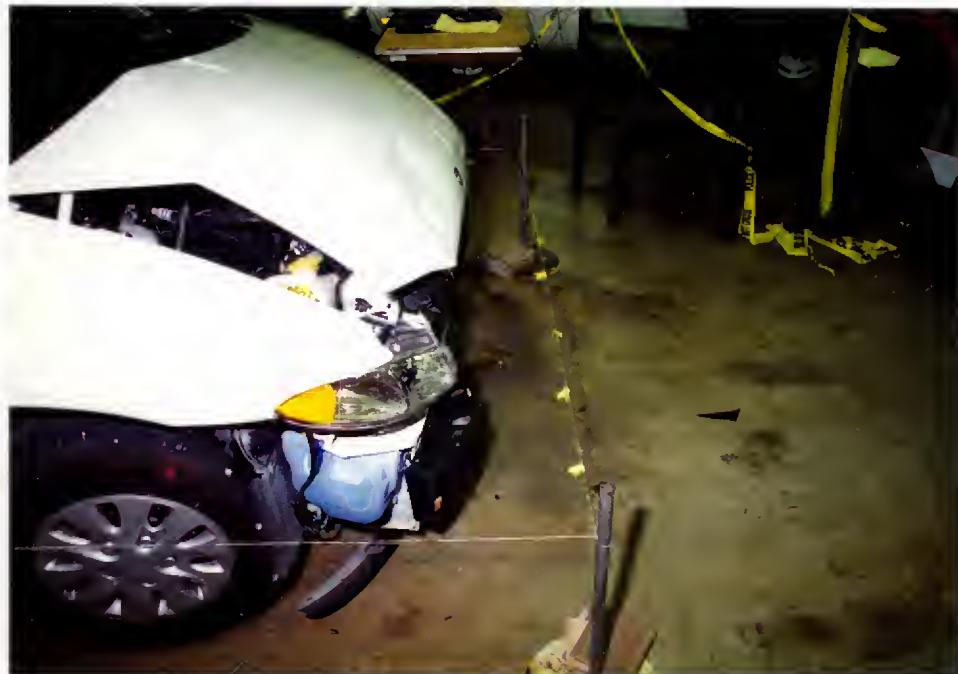
30. Right front perpendicular view documenting the crush profile.

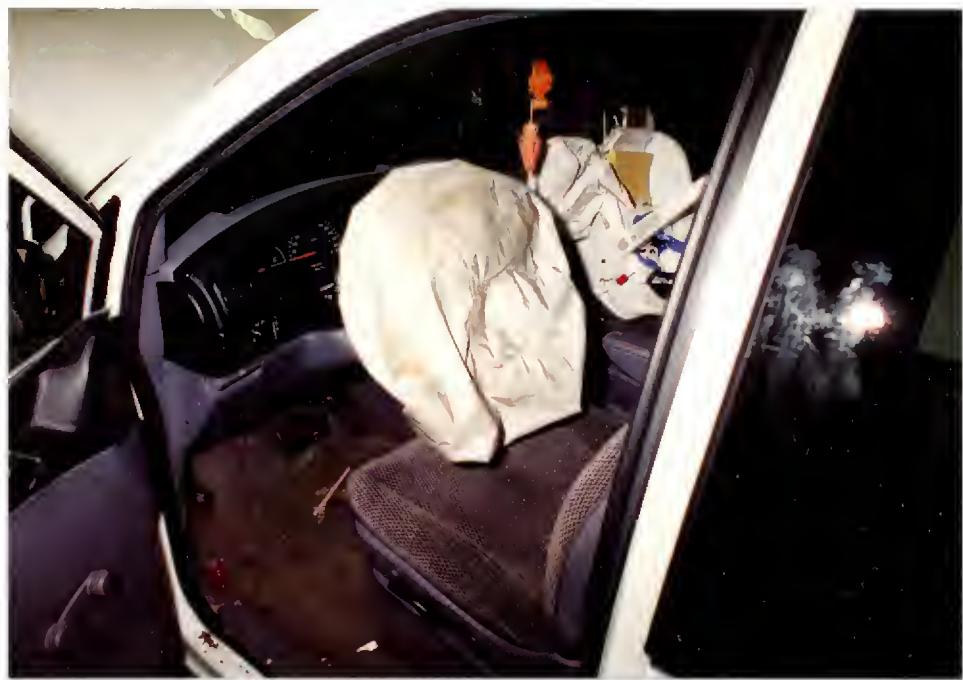
33. Overall view of the driver's compartment and the deployed driver side air bag.

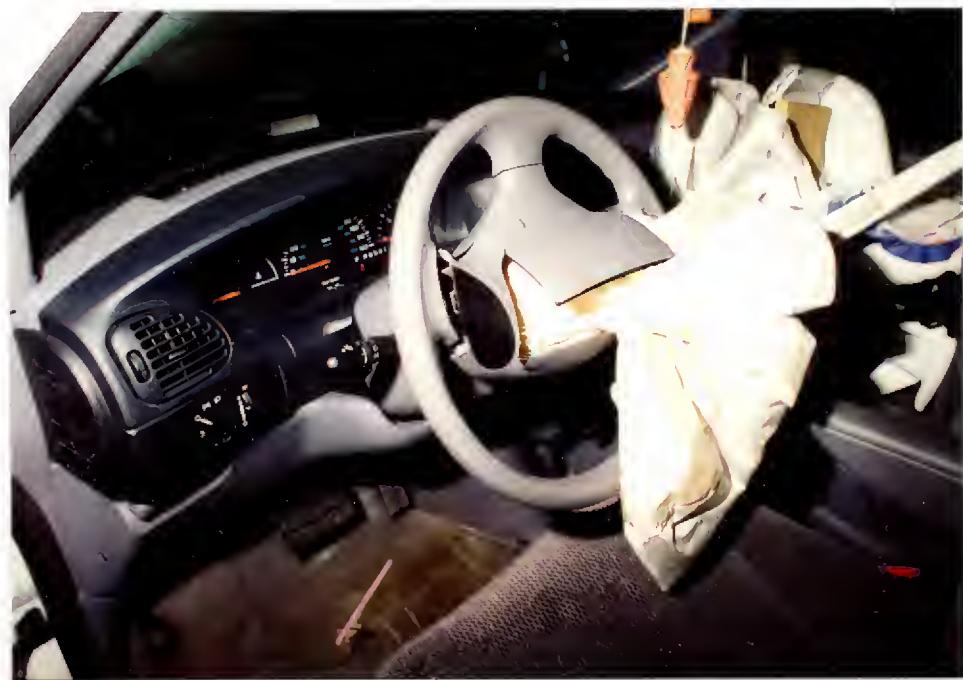
The driver's side air bag deployed as designed from the H-configuration module cover flaps. A blood and dirt-like stain was noted to the mid right side of the driver bag. This stain occurred post-crash as the driver attended to the injured infant right front occupant. It should be noted that the steering wheel was rotated 180 degrees at the time of our inspection and remained in this position for the photographic documentation which is included as Attachment A of this report.

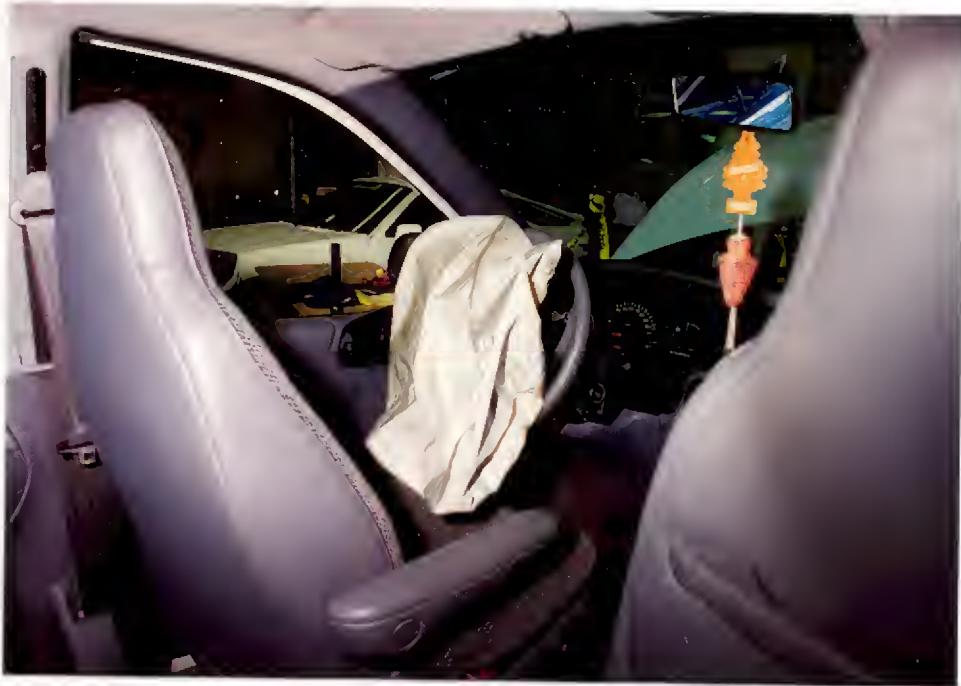
39. View of the driver side air bag.

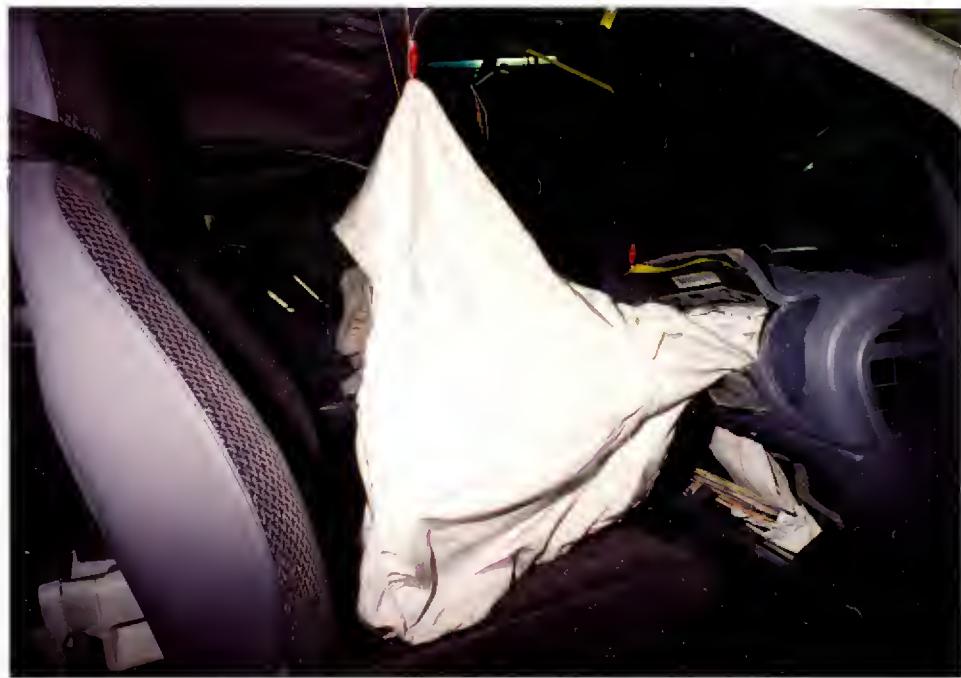
The passenger side air bag deployed from the symmetrical flap configuration module that was mounted within the mid instrument panel of the vehicle. The passenger side air bag membrane and the upper module cover flap exhibited evidence of contact with the back side of the rearward-facing Century infant restraint. A 5.1 cm (2.0") vertically oriented tear was noted to the bottom panel of the passenger side air bag. The frayed fabric ends were singed from the hot gas venting through the tear point. The contact evidence is identified in the Automatic Restraint System section of this report.

46. Close-up view of the deployed passenger side air bag and cover flaps, right instrument panel, and the opened glove compartment door.

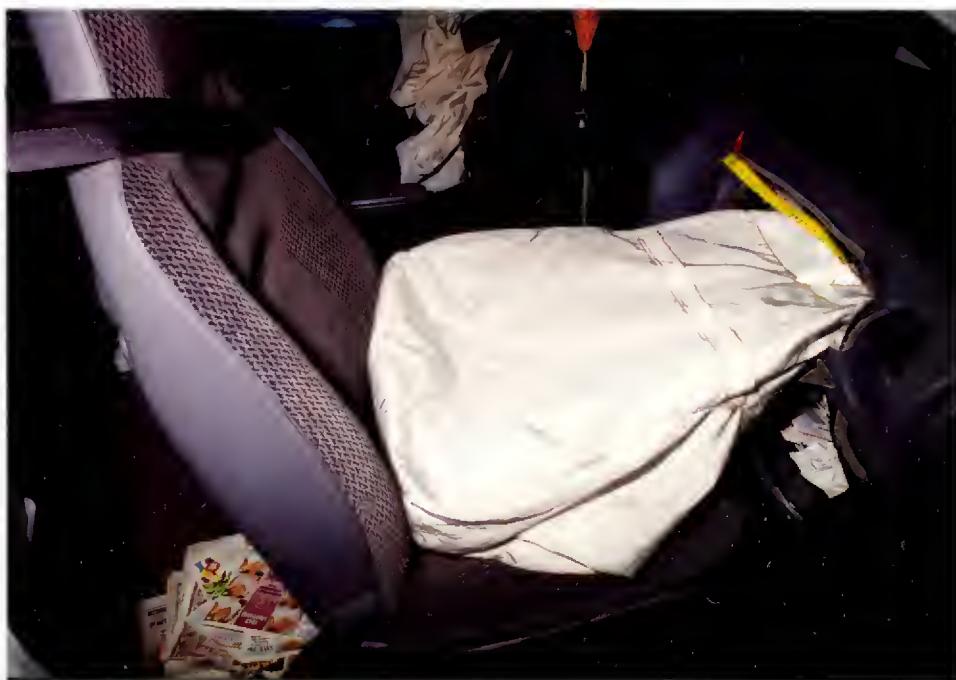
The passenger side air bag was a non-tethered bag with no vent ports. The bag probably exhausted through the porous membrane. The rearward excursion of the passenger side air bag was 58.4 cm (23.0") from the module and 45.7 cm (18.0") from the protruding mid instrument panel. The throat of the bag extended 25.4 cm (10.0") outboard of the inflator to the seam attaching the bag to the inflator assembly. The wide band of stitching was used as a reference point to locate contact evidence that was observed on the bag. The vertical height of the face of the bag was 68.6 cm (27.0") and the width was 47.0 cm (18.5"). Vertically oriented blue cloth transfers were noted on the passenger side air bag from contact with the fabric liner of the child restraint. A 5.1 cm (2.0") long vertical tear was located on the left side of the bag at the stitched seam. The frayed edges of the tear were scorched from the hot gas exhausting from the bag (refer to Photograph No. 59).

48. Rearward excursion of the non-tethered passenger side air bag.

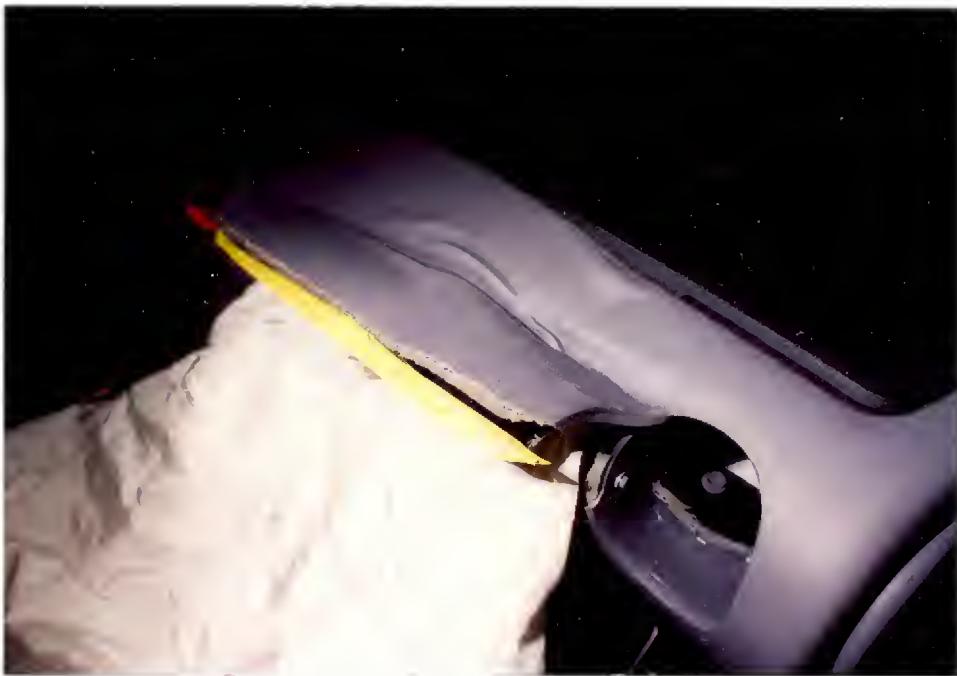
51. View of the top module cover flap and the displaced right vent louver.

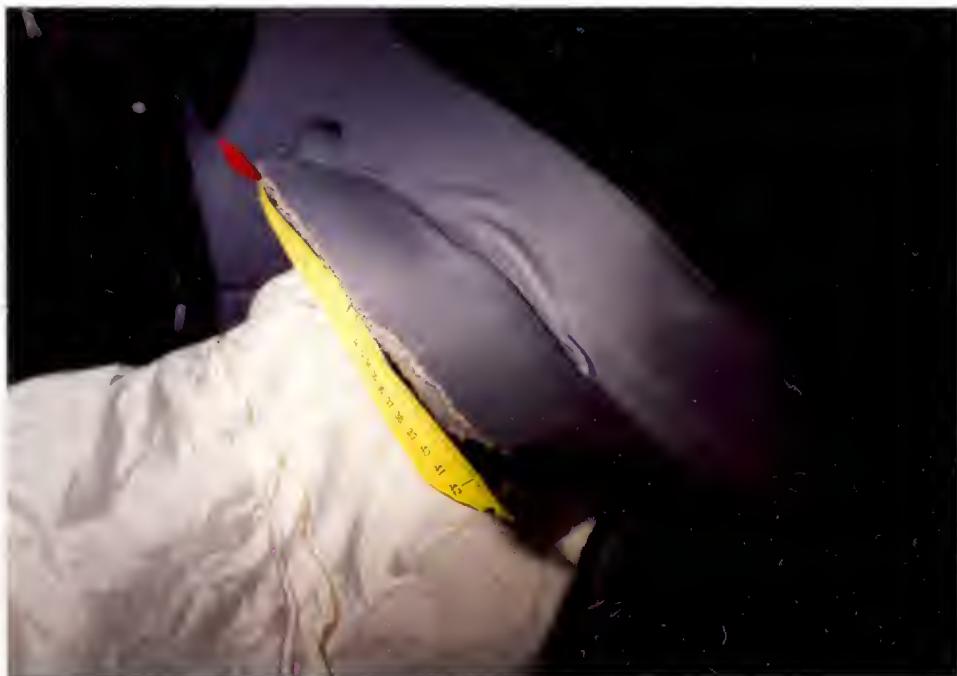
52. Child restraint white vinyl transfers on the upper cover flap.

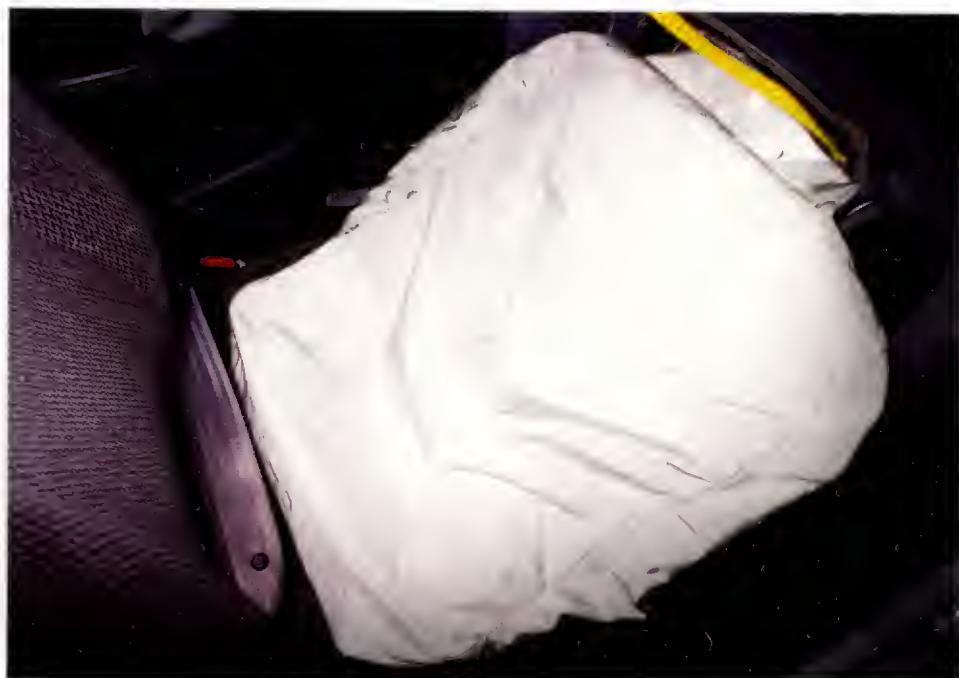
54. Overall view of the passenger side air bag.

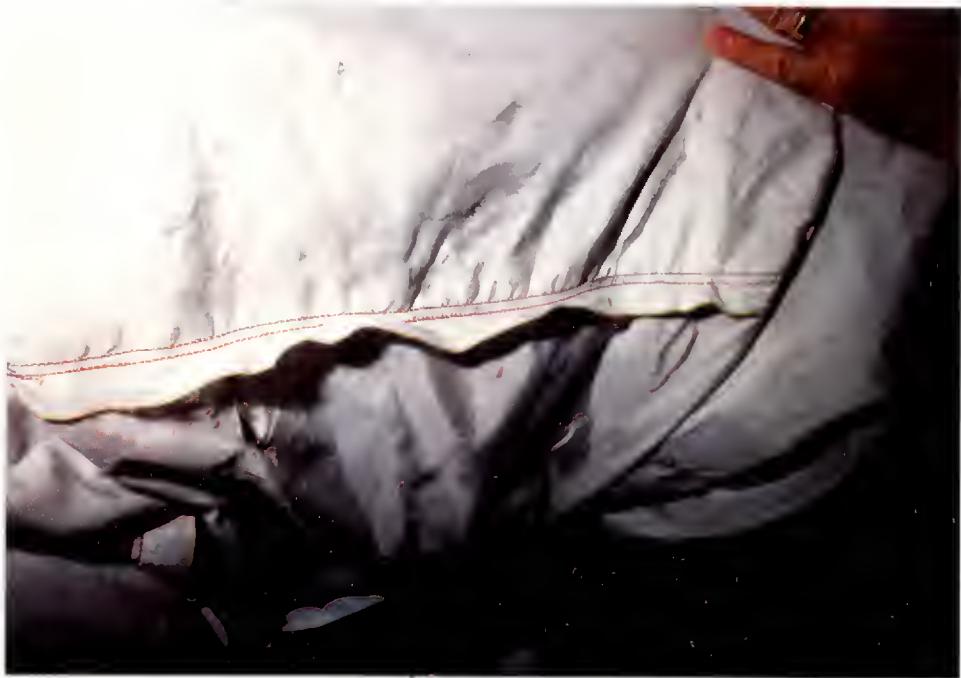
57. Blue cloth transfer located on the bottom of the bag.

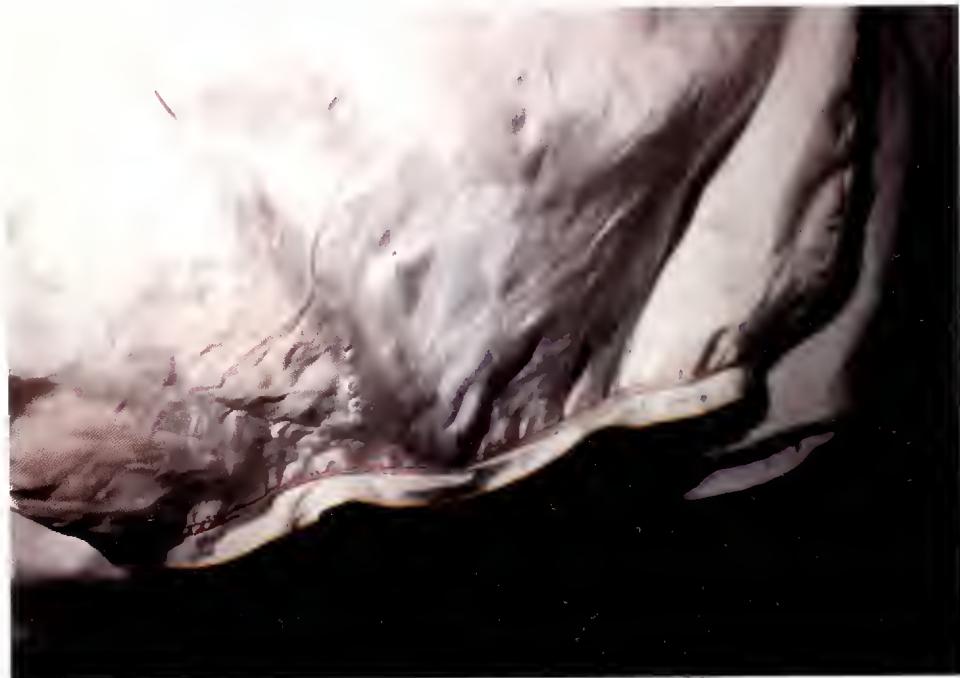
58. Close-up view of the blue cloth transfer.

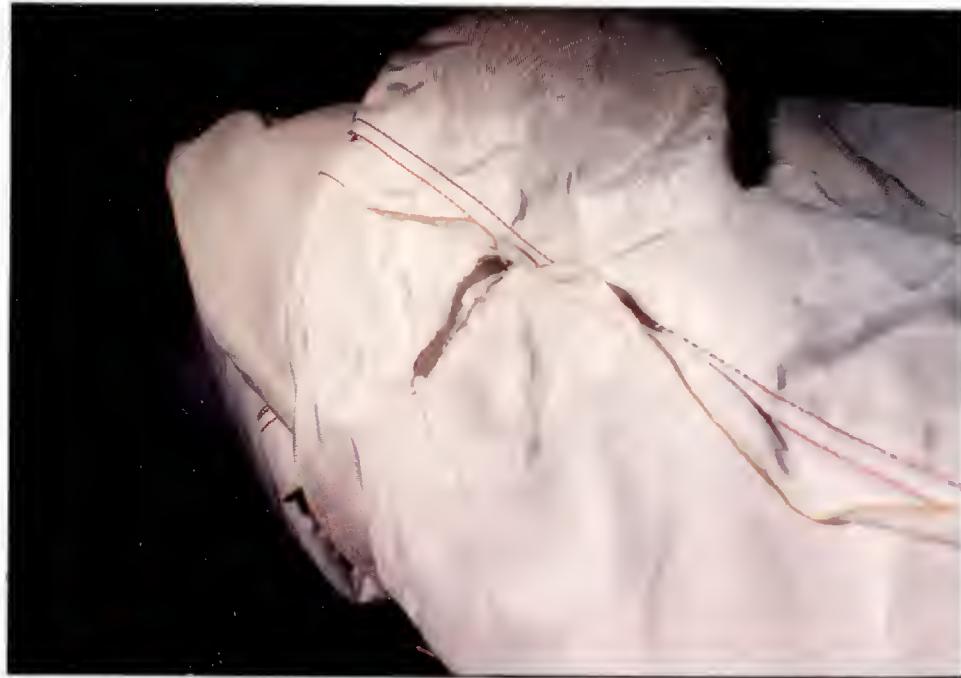
59. Close-up view of the 5.1 cm (2.0") vertical tear on the left side of the passenger side air bag.

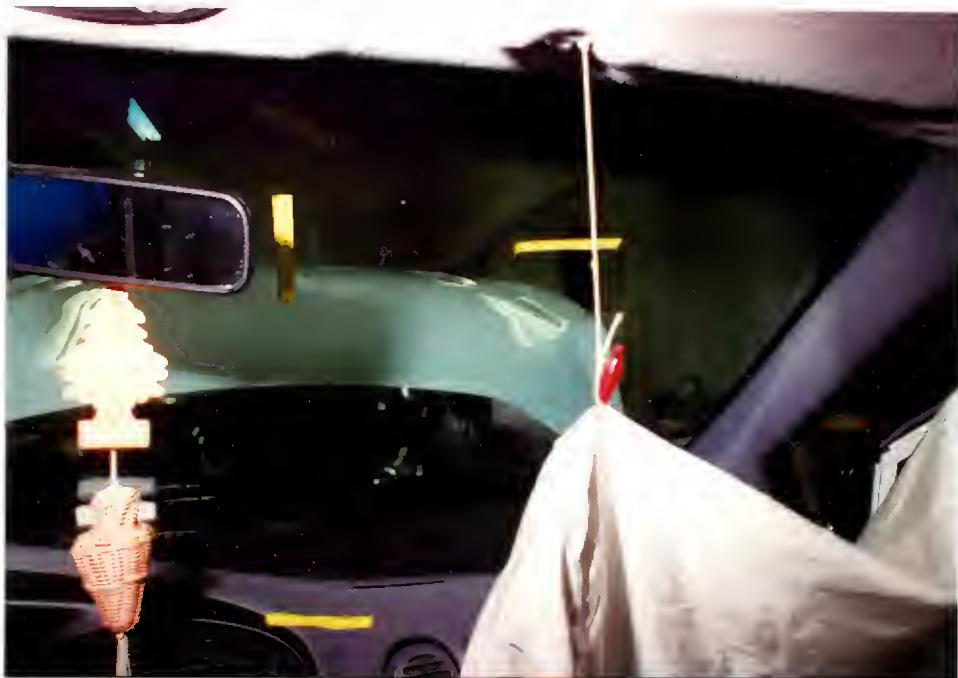
60. Grease-type semi-circular transfer and possible white vinyl transfer on windshield right of center.

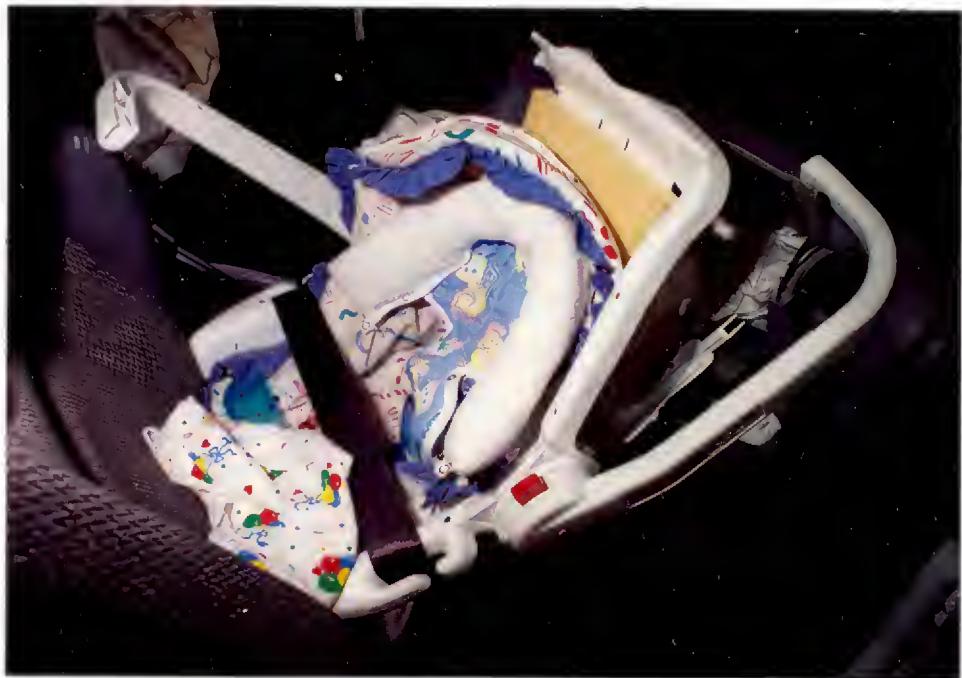
69. Right front lap belt securing the child restraint in place at the time of the crash.

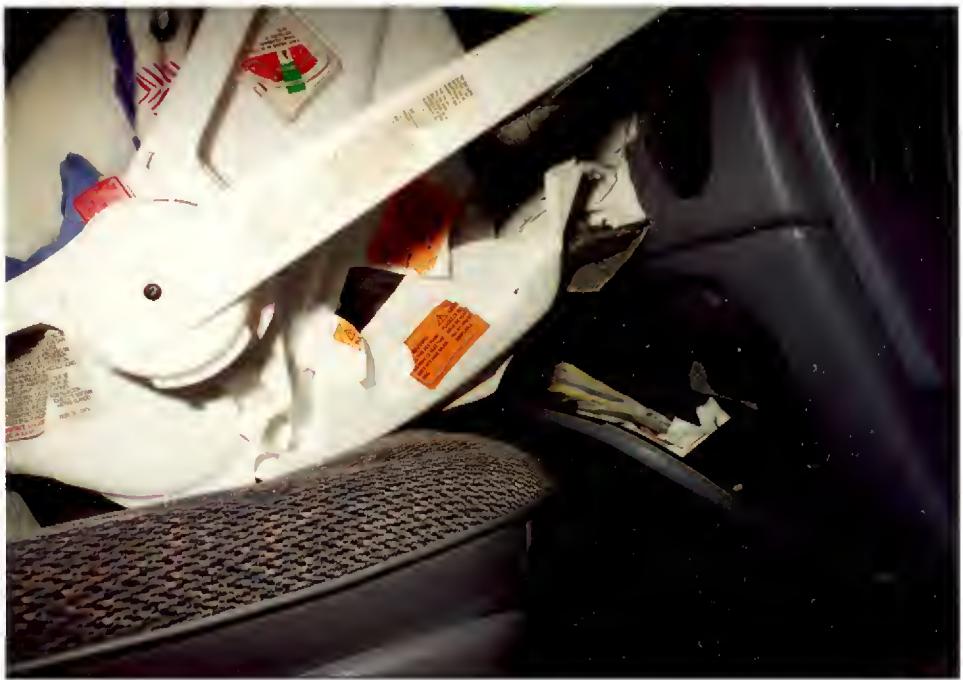
The restraint was positioned between the seat back support and the mid mount passenger side air bag module assembly. At impact, the deploying air bag and symmetrical cover flaps contacted the upper aspect of the shell. The contact fractured the shell in both the vertical and longitudinal directions. The lower outboard aspect of the restraint had a 21.6 x 17.8 cm (8.5 x 7.0") section that was completely separated from the shell.

70. Close-up view of the child restraint positioned against the panel and mid-mount air bag module assembly.

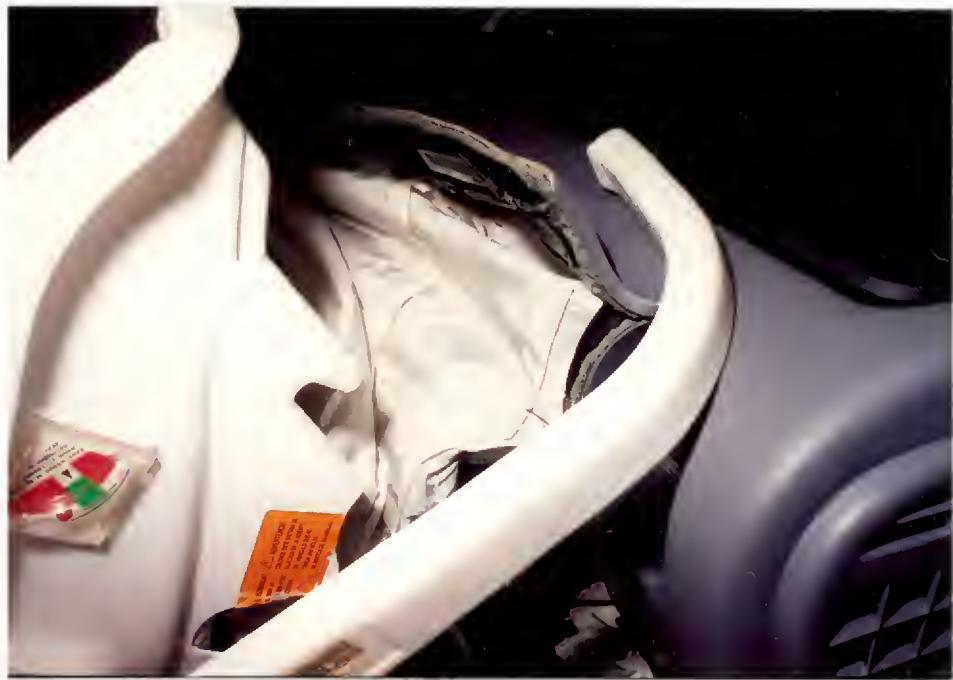
At impact, the driver and passenger side air bag system deployed. The passenger side air bag module cover flaps opened against the back side of the plastic shell of the rearward-facing infant restraint. The symmetrical H-configuration module cover flaps, in combination with the deploying air bag membrane, fractured the back side of the plastic shell of the infant restraint and accelerated the restraint in a rearward direction with respect to the vehicle. White vinyl-type transfers were noted across the full width of the upper module cover flap. Two similar transfers were noted to the upper corner areas of the lower cover flap. The deploying air bag subsequently contacted the shell of the restraint, which in combination with the cover flap contact, severely fractured the restraint in both the lateral and longitudinal directions.

71. View of the plastic shell fracture caused by the air bag module cover flaps.

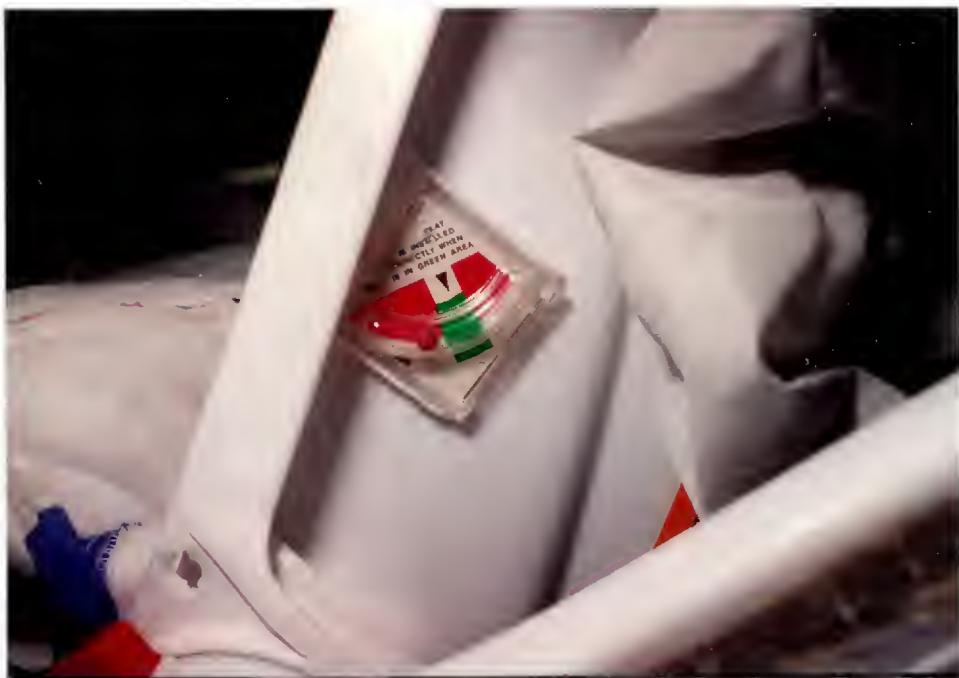
72. View of the fractured child restraint handle against the upper module cover flap.

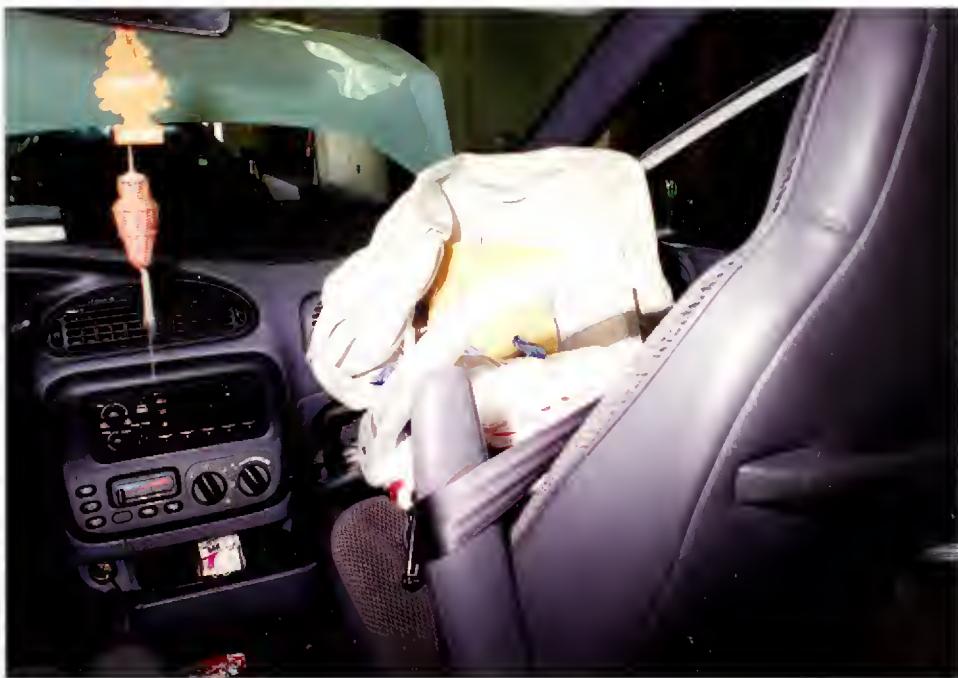
75. Rear view of the rearward facing child restraint in the right front seat.

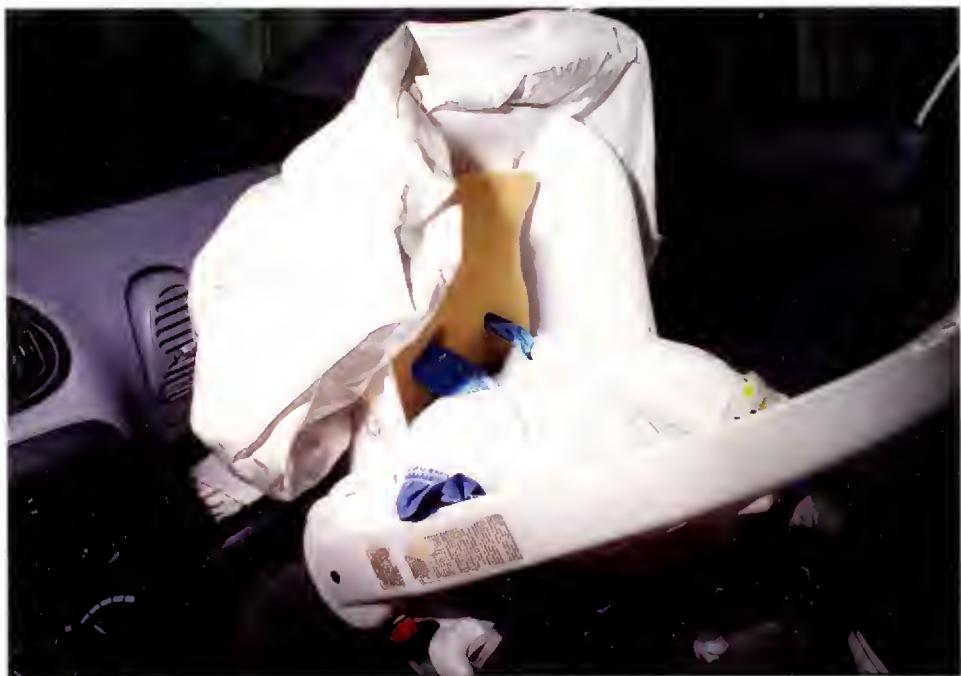
76. Close-up view of the deployed air bag and child restraint.

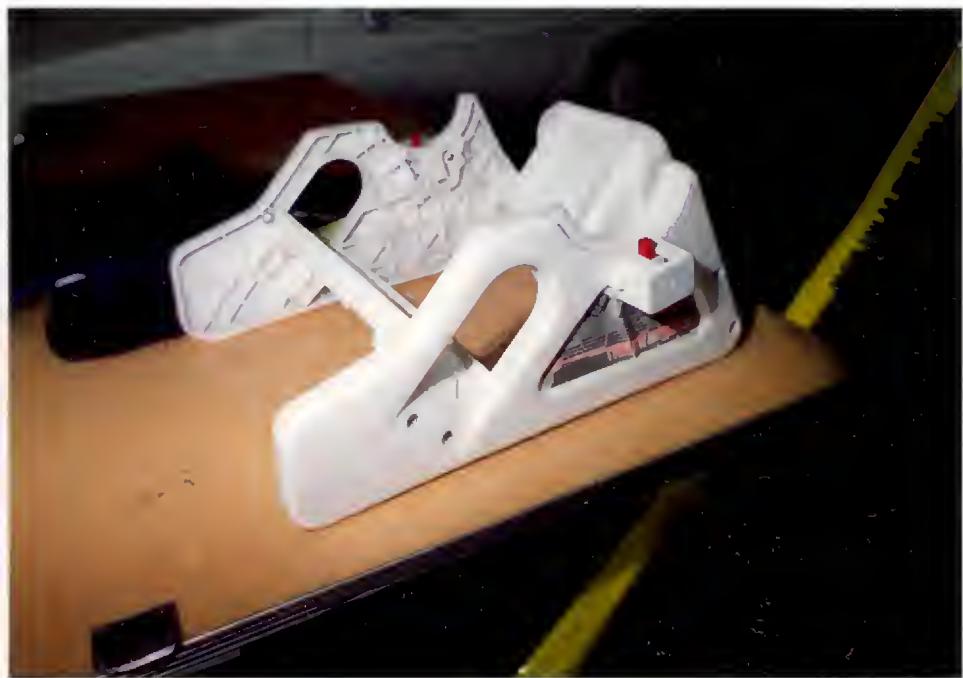
95. Close-up view of the damage to the top of the child restraint.

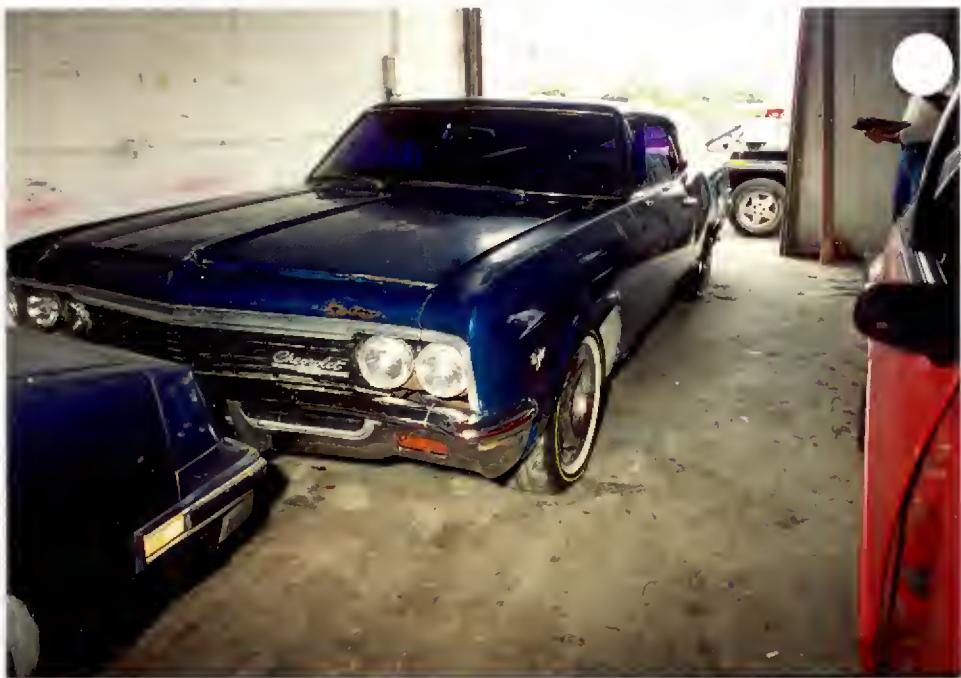
101. Left front three-quarter view of the 1966 Chevrolet Impala.

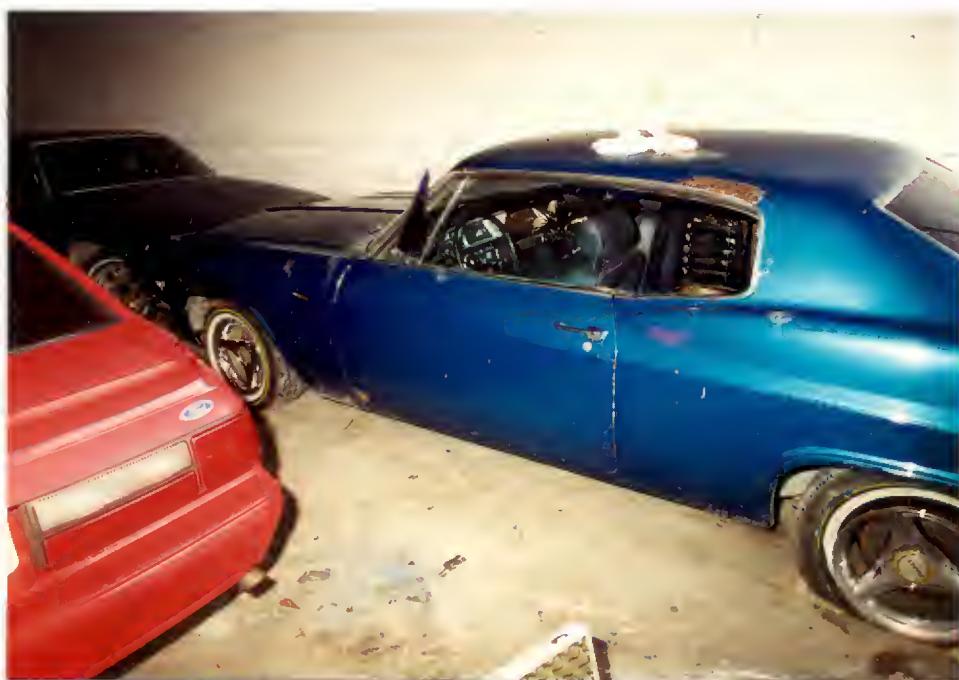
102. Left side view of the Chevrolet Impala.

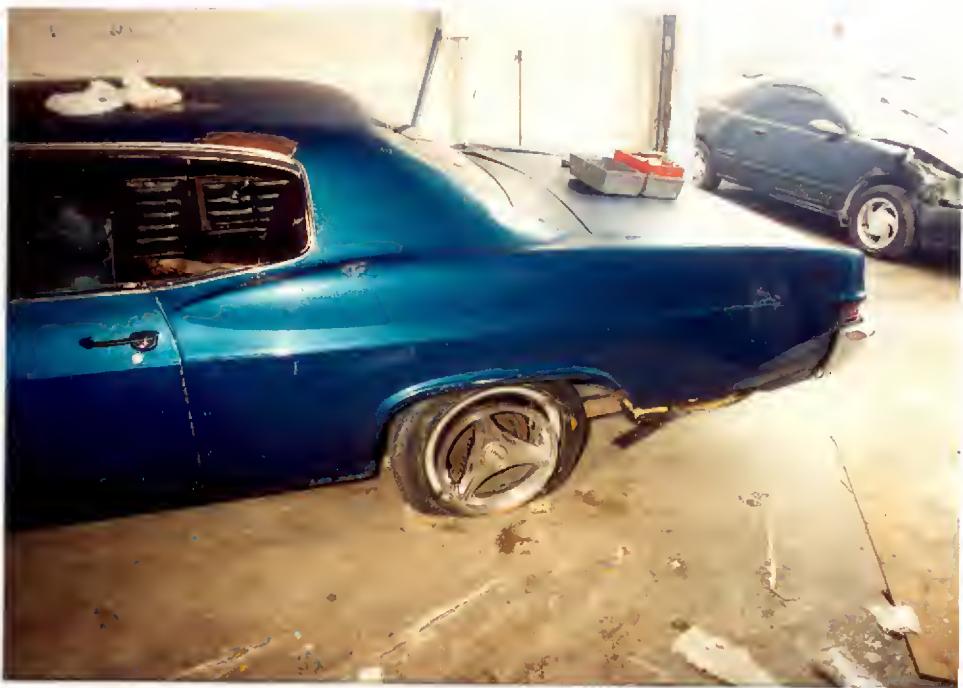
103. View of the left rear quarter panel and wheel.

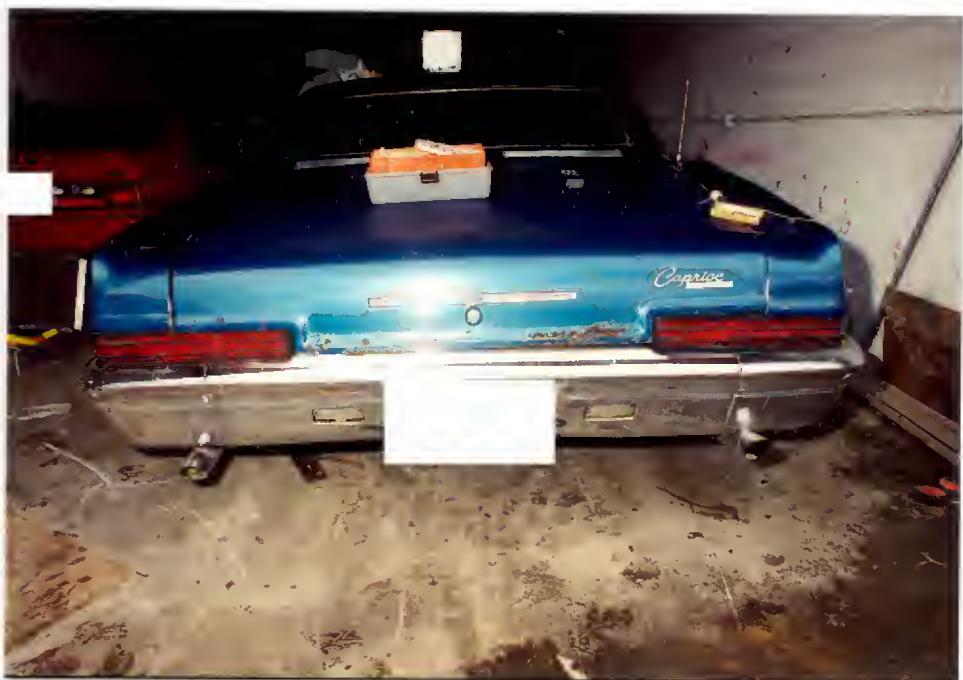
104. Rear view of the Chevrolet Impala.

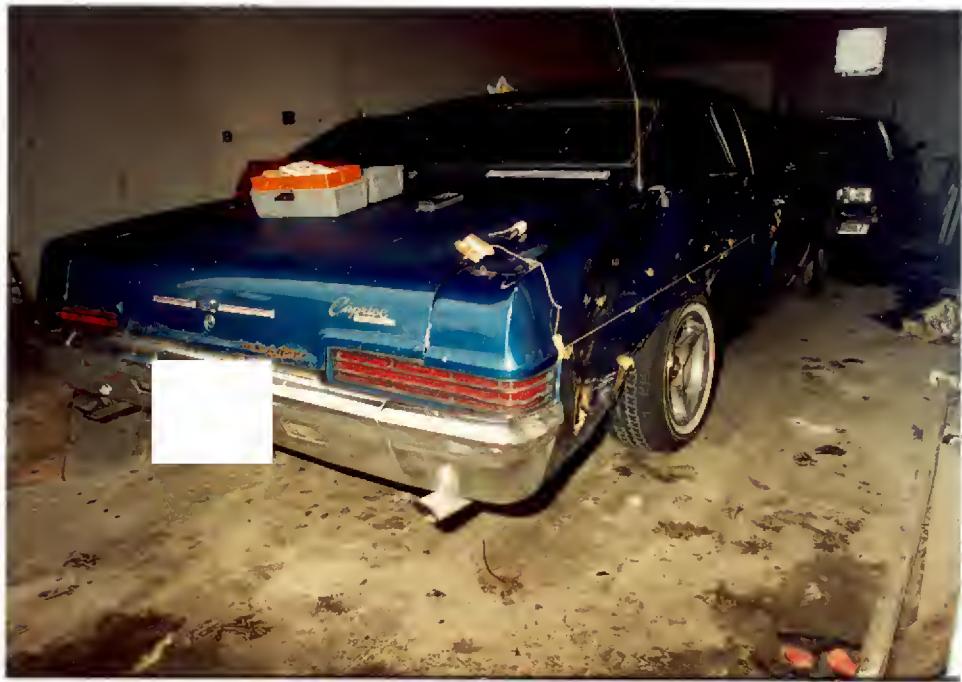
105. Right rear three-quarter view.

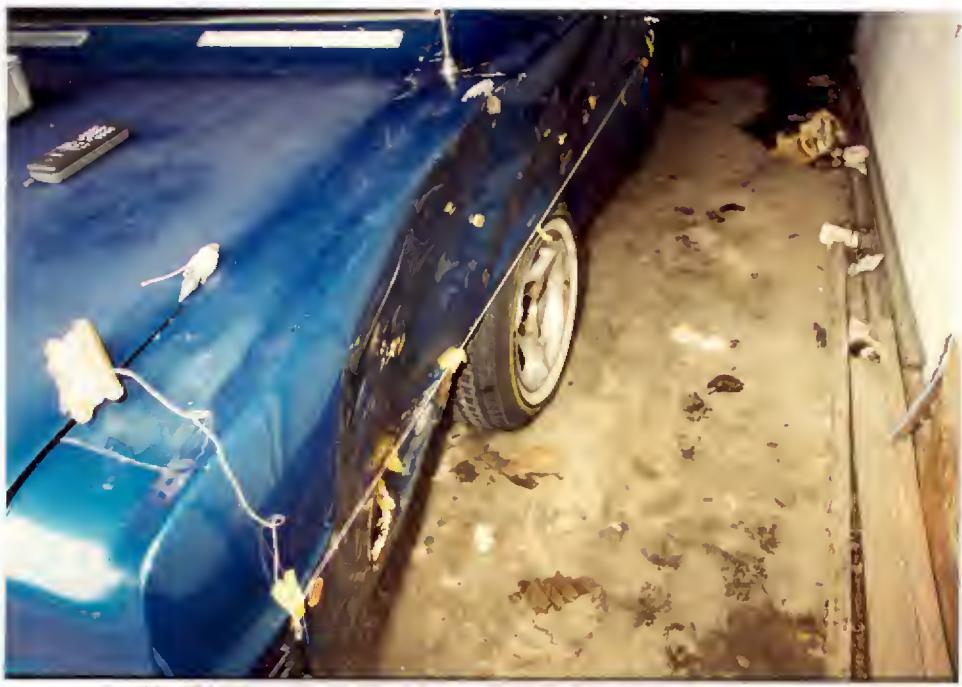
106. Longitudinal view showing the depth of crush to the right rear quarter panel of the Chevrolet Impala.

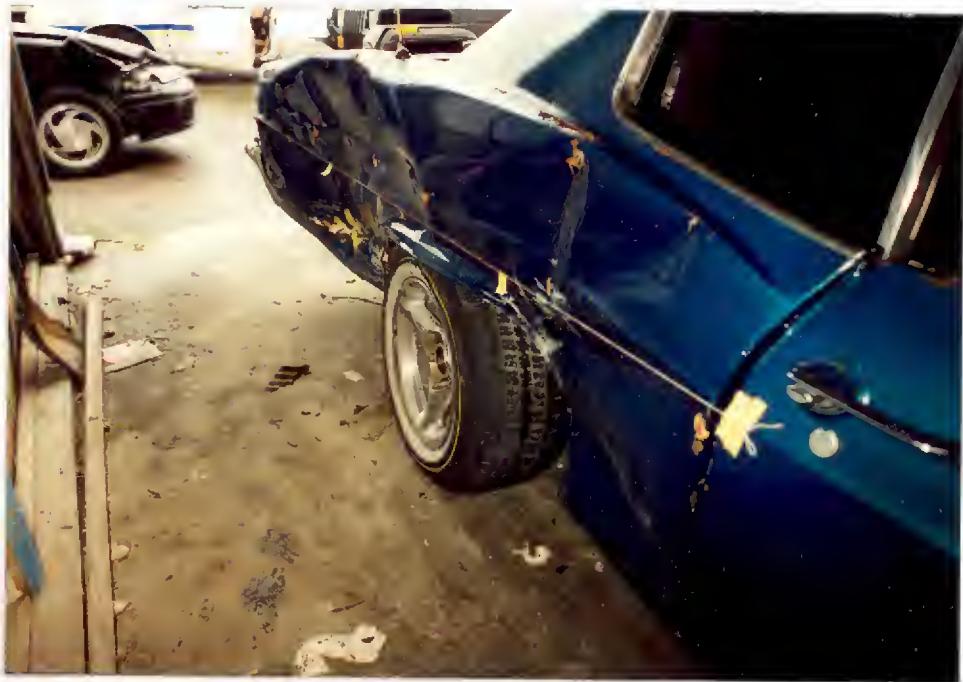
The Chevrolet Impala sustained moderate damage to the right rear quarter panel from its impact sequence with the Dodge Caravan. Maximum crush was 15.2 cm (6.0") located 41.9 cm (16.5") forward of the right rear axle. The direct contact damage began 72.4 cm (28.5") forward of the right rear axle and extended 188.0 cm (74.0") rearward. The combined induced and direct contact damage began at the left B-pillar and extended 215.6 cm (84.9") rearward to the trailing end of the quarter panel. The crush profile was documented at a height of 61.0 cm (24.0") above ground level (mid-door level) and was as follows: $C_1 = 0$ cm (0"), $C_2 = 13.3$ cm (5.25"), $C_3 = 11.4$ cm (4.5"), $C_4 = 8.6$ cm (3.4"), $C_5 = 13.3$ cm (5.25"), $C_6 = 1.9$ cm (0.75").
